Technical Report 627

CABLE FAILURES IN THE AN/BQS-15 SONAR SYSTEM

Analysis of failures in the depression/elevation
drive-motor power cable and recommendations
for their prevention

NAVAL OCEAN SYSTEMS CENTER
SAN DIEGO, CALIFORNIA 92152

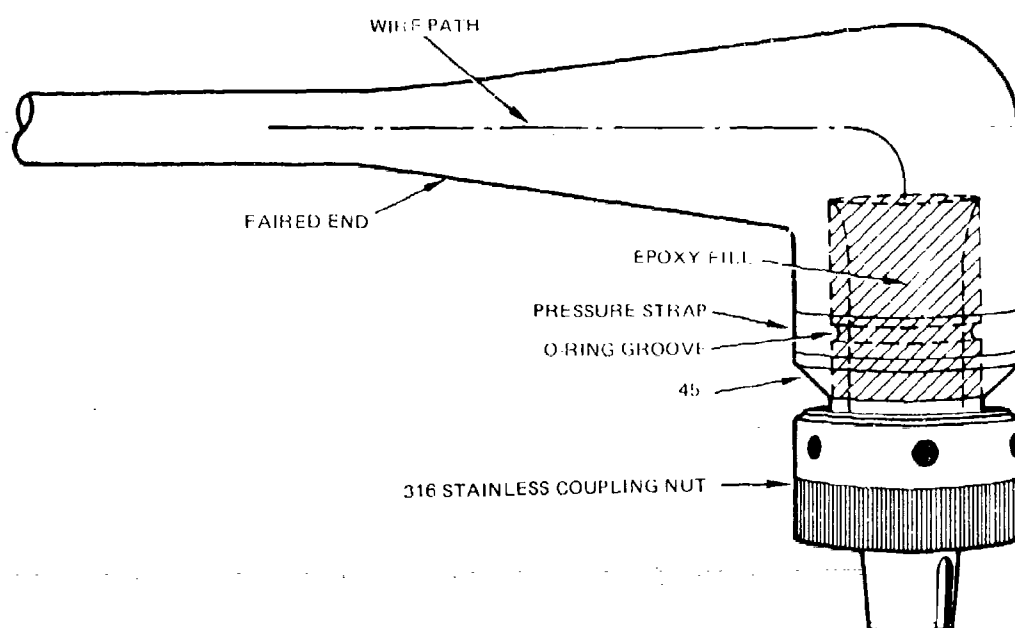
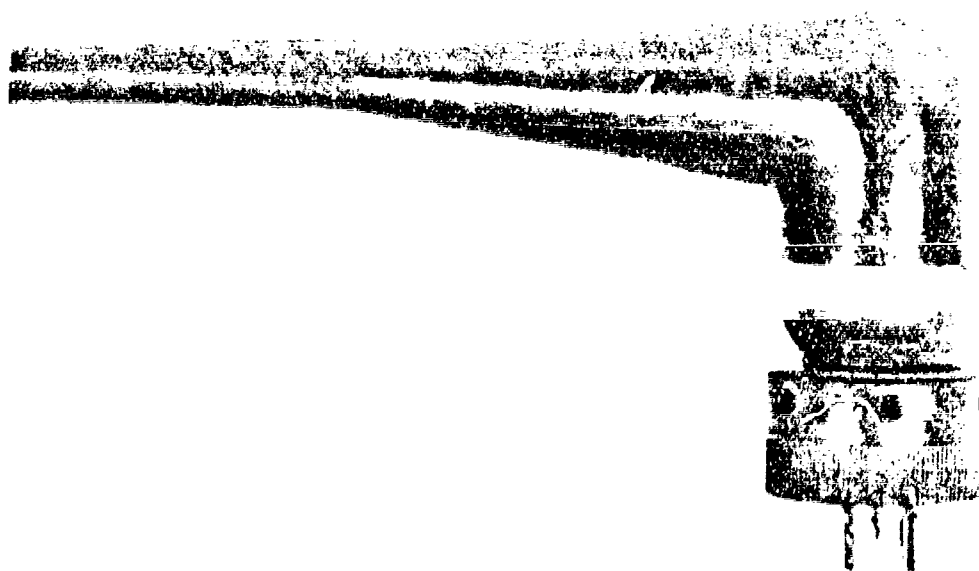
Figure 16. Proposed change for connector P2 of cable W 31.

a. Recommended internal modification to the MH-C-2421 2/3-001 connector.

b. External modification

The material used for a water block in the system should not extend into the stress relief portion of the mold but should be terminated at the end of the metal sleeve. Additionally, the stress relief portion of the mold should be faired into the cable rather than terminate as a step at the cable end. The cutout portion of the smaller MIL-C-24217/3-001 connector should be eliminated, the lines routed up and over the metal sleeve, and the mold changed to accommodate this in a manner similar to that of MIL-C-24231/2-001. A sketch showing this can be seen in figure 16. It illustrates the 90° termination, the fairing into the cable, routing of the wires around the rear of the metal sleeve, the epoxy water block, a metal pressure strap, and an O-ring groove in the metal sleeve directly under the metal strap. The metal strap is recommended since there have been laboratory results (at NUSC) showing that its use apparently aids in the tolerance of the bond to a severe pressure environment. Some results using the strap have shown bond failure in all areas except directly below the metal strap. Installation of the metal strap can be simple. One method would be to tighten the strap so that the exposed surface of the strap just becomes flush with the exterior surface of the neoprene. A buckle would be used to tie the strap in a manner presently used on many deep-submersible transducers. A specially designed tool has been fabricated for this purpose; details of the tool are available from NOSC.

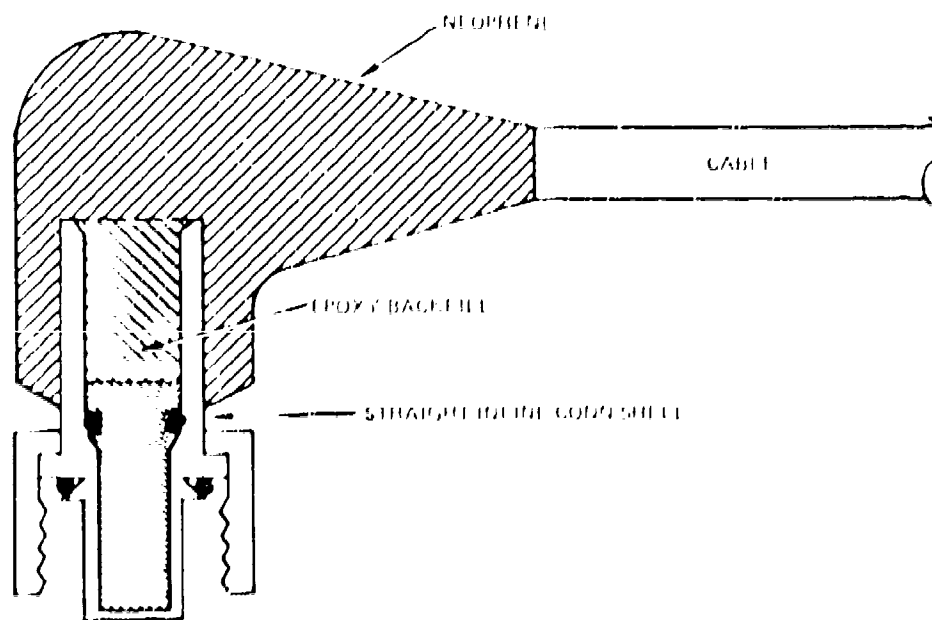
Figure 2. DVA molded right angle connector.
